UDFCD ALERT Network 2010 End of Year Report

Prepared for:
Kevin Stewart
Urban Drainage and Flood Control District
Denver, Colorado

Prepared by:
Water & Earth Technologies, Inc.
1225 Red Cedar Circle, Suite A
Fort Collins, CO 80524
(970) 225-6080

December 2010

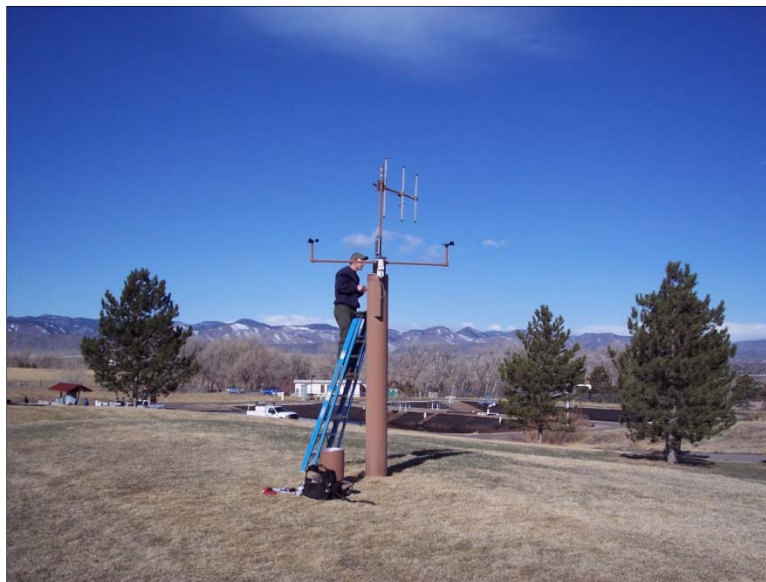
Photo 3-1. Highlands Ranch Wx

On December 9, 2010 a final inspection was performed. Since this is a weather station, it is operational throughout the winter so the transmitter was not removed. All equipment was checked, cleaned and tested. The wind direction sensor needs replacement. All other equipment was in working order.

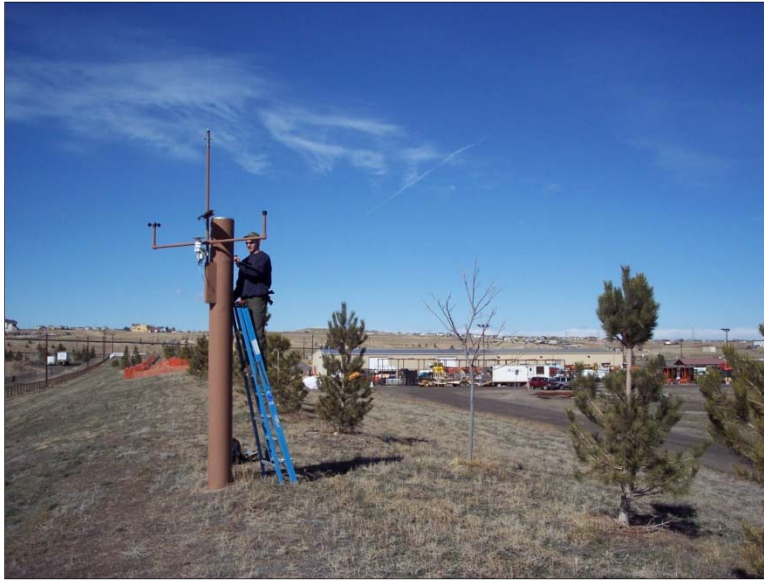
Photo 3-2. Salisbury Park Wx

On December 9, 2010 a final inspection was performed. Since this is a weather station, it is operational throughout the winter so the transmitter was not removed. All equipment was checked, cleaned and tested. All equipment was in working order.

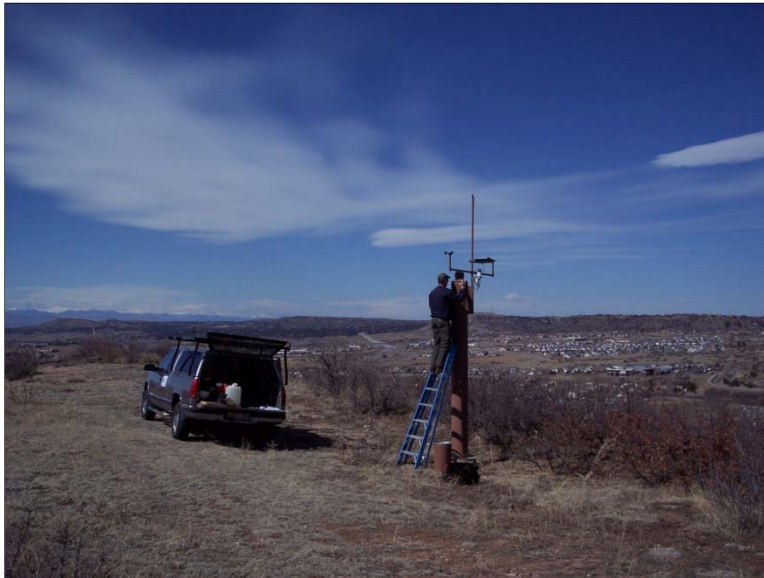
Photo 3-3. Castle Rock Wx

The weather station at Castle Rock was visited for a full service inspection on March 16, 2010. All equipment was checked, cleaned and tested. All equipment was in working order.

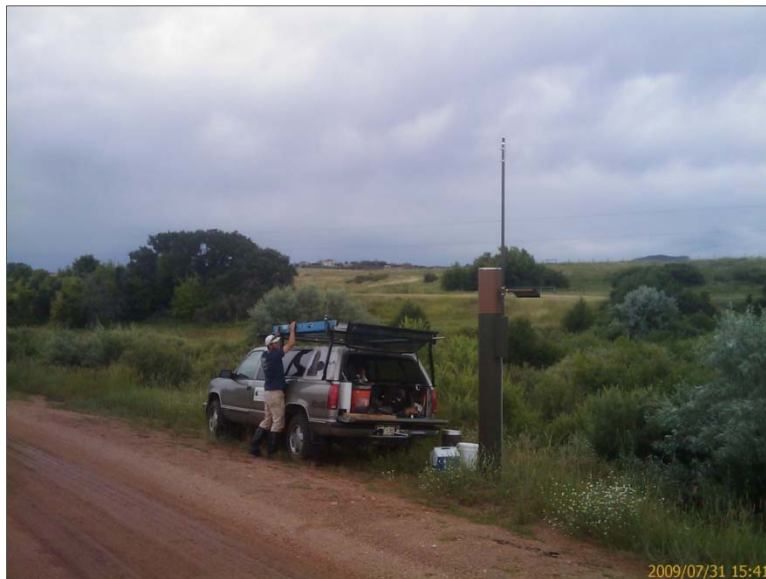
Photo 3-4. Pine Cliff PS

A second mid-season inspection was conducted on August 13, 2010. All equipment was checked, cleaned and tested. All equipment was in working order. The Hydrolynx bucket on top of the High Sierra standpipe had a poor fit. To improve the fit, the top of the standpipe was modified with new holes and rivets.

On October 29, 2010 winter shut-down activities were performed. The transmitter was removed and the PT was pulled up into its winter location. All equipment was in working order.

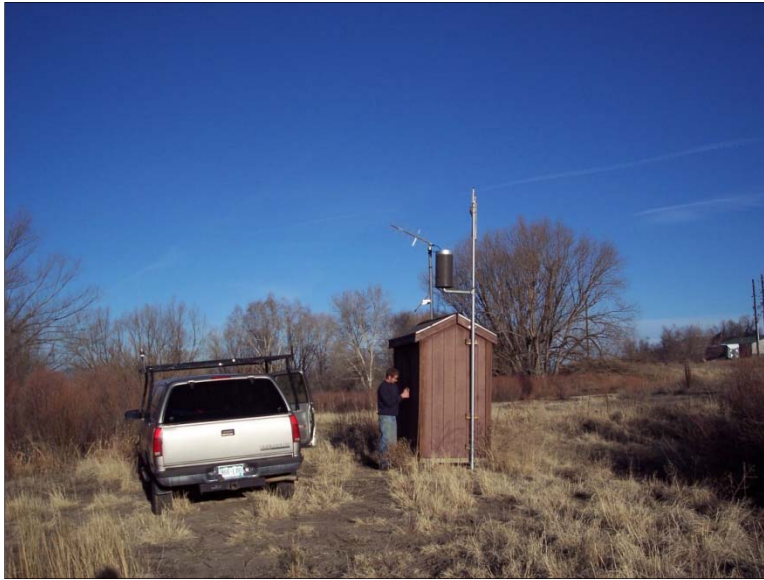
Photo 3-5. Haskins Gulch P

The mid-season inspection was conducted on July 20, 2010. All equipment was checked, cleaned and tested. All equipment was in working order.

On October 29, 2010 winter shut-down activities were performed by removing the transmitter.

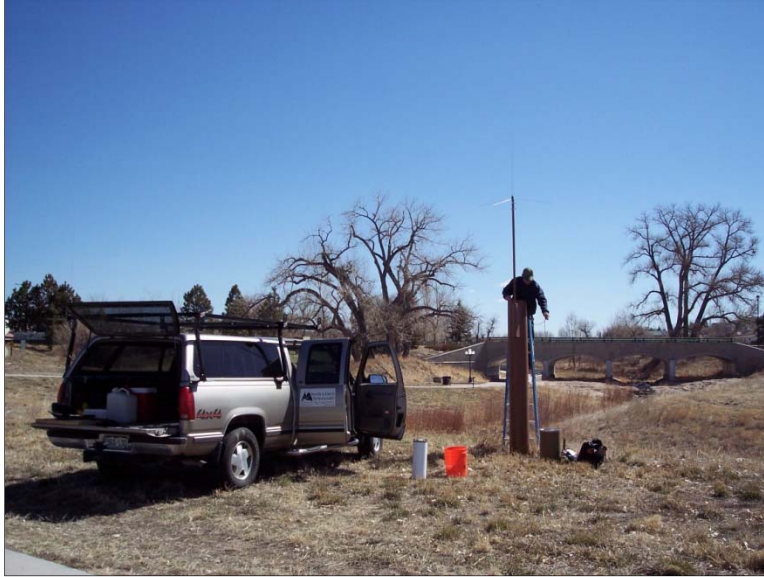
Photo 3-6. Sulphur Gulch PS

A second mid-season inspection was conducted on August 12, 2010. All equipment was checked, cleaned and tested. All equipment was in working order.

On October 29, 2010 winter shut-down activities were performed. The transmitter was removed and the PT was pulled up into its winter location. All equipment was in working order.

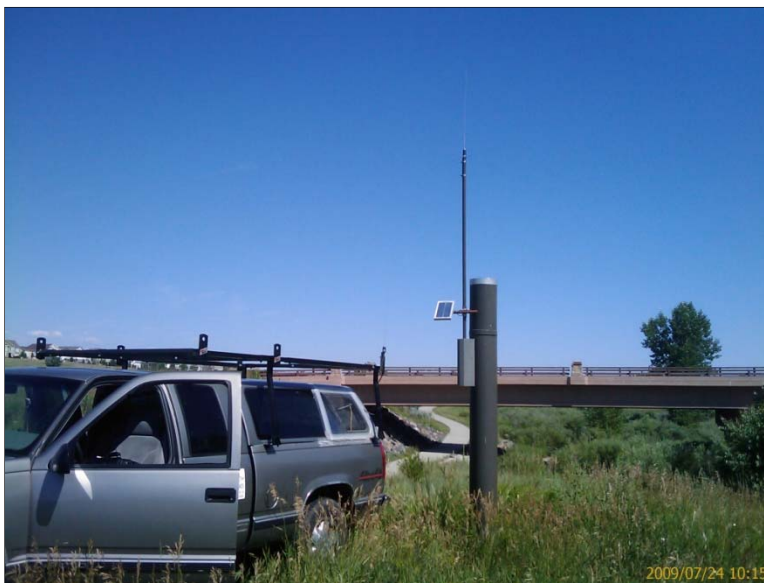
Photo 3-7. Cherry Creek at Bayou Gulch PS

The pre-season inspection was conducted on March 16, 2010. All equipment was checked, cleaned and tested. The PT required recalibration. All equipment was in working order.

On June 15, 2010 a service call was made because PT values were transmitted every minute. The PT was disconnected from the transmitter to alleviate the problem.

The mid-season inspection was conducted on June 30, 2010. All equipment was checked, cleaned and tested. The faulty PT was pulled for repair. All other equipment was in working order.

On August 20, 2010 a troubleshooting call with High Sierra revealed that the problem was not with the PT, but rather with the transmitter. The transmitter was sent to High Sierra for repair. A spare transmitter was deployed at the site.

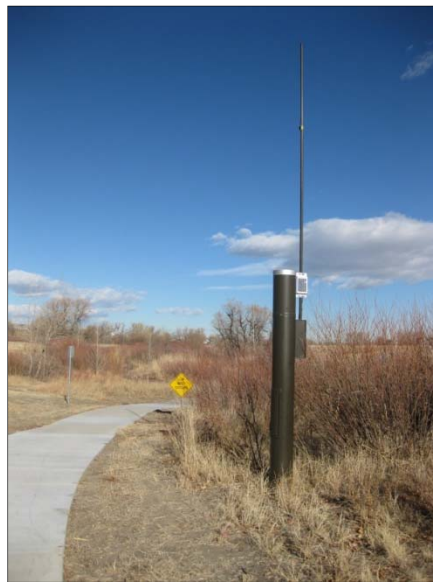
Photo 3-8. Cherry Creek at Stroh Road PS

The pre-season inspection was conducted on March 16, 2010. All equipment was checked, cleaned and tested. The PT required recalibration. All other equipment was in working order. It was noted that the riser pipe and intake line were not set in concrete and had loosened over the winter months.

The mid-season inspection was conducted on June 30, 2010. All equipment was checked, cleaned and tested. All equipment was in working order.

A second mid-season inspection was conducted on August 12, 2010. All equipment was checked, cleaned and tested. All equipment was in working order.

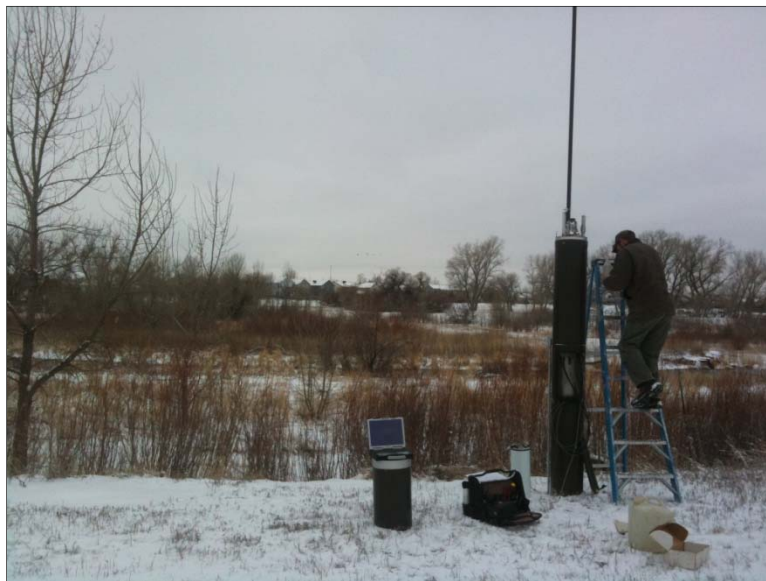
Photo 3-9. Cherry Creek at Cottonwood PS

The mid-season inspection was conducted on July 1, 2010. All equipment was checked, cleaned and tested. The PT required recalibration. All other equipment was in working order. The ½” conduit connection to the riser pipe sheared when the cap was removed. Everything still works, but the ½” connection will have to be repaired.

A second mid-season inspection was conducted on August 12, 2010. All equipment was checked, cleaned and tested. The PT required recalibration. All other equipment was in working order.

On October 29, 2010 winter shut-down activities were performed. The transmitter was removed and the PT was pulled up into its winter location. All equipment was in working order.

Follow-Up Replace 1/2 in. conduit at riser pipe because it sheared while attempting to remove cap

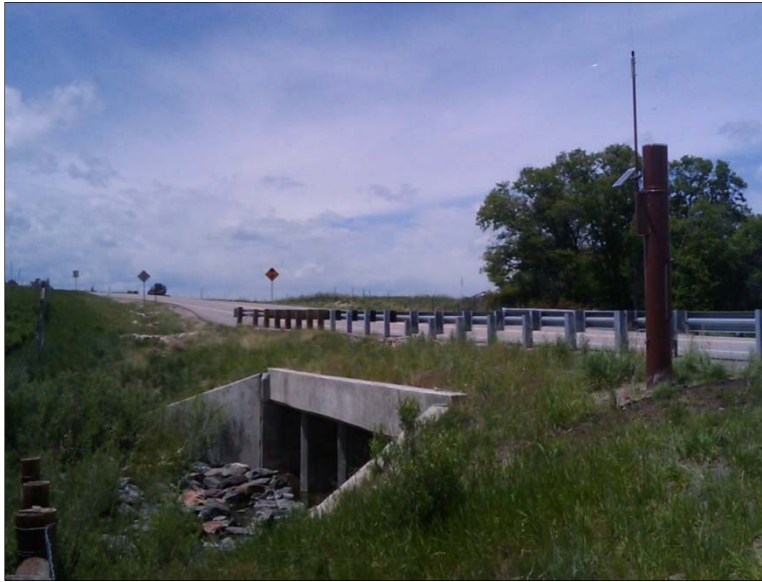
Photo 3-10. Russelville Gulch P

The mid-season low impact inspection was performed on June 30, 2010. All tested equipment was in working order.

On October 29, 2010 winter shut-down activities were performed by removing the transmitter.

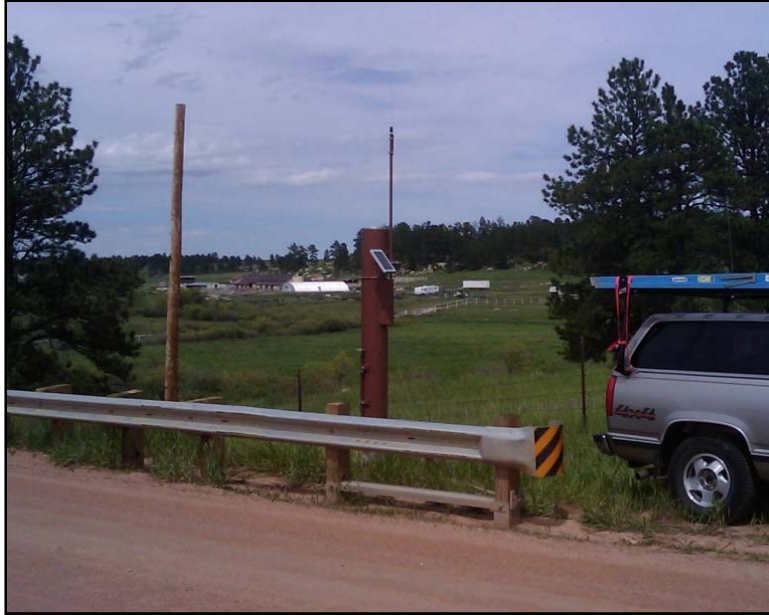
Photo 3-11. East Cherry Creek P

The mid-season low impact inspection was performed on June 30, 2010. All tested equipment was in working order.

On October 29, 2010 winter shut-down activities were performed by removing the transmitter.

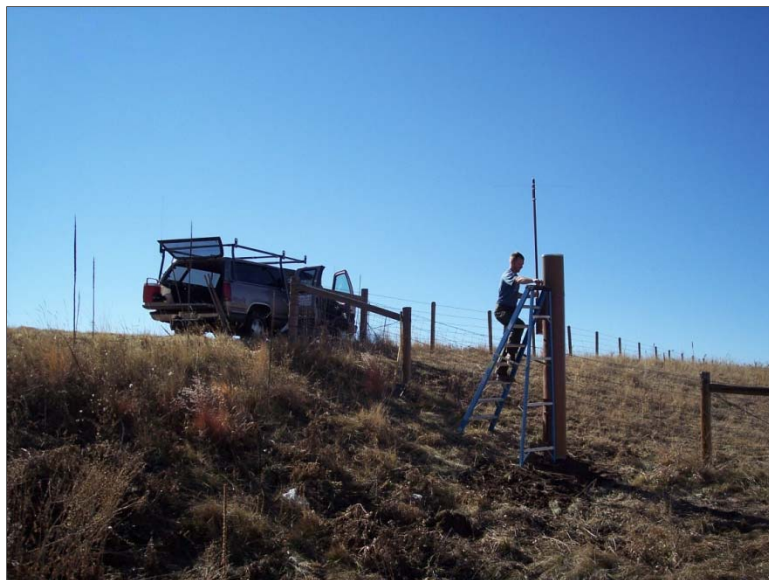
Photo 3-12. West Cherry Head P

The station at West Cherry Head was activated for the season on March 18, 2010. All equipment was checked, cleaned and tested. All equipment was in working order.

The mid-season low impact inspection was performed on June 30, 2010. All tested equipment was in working order.

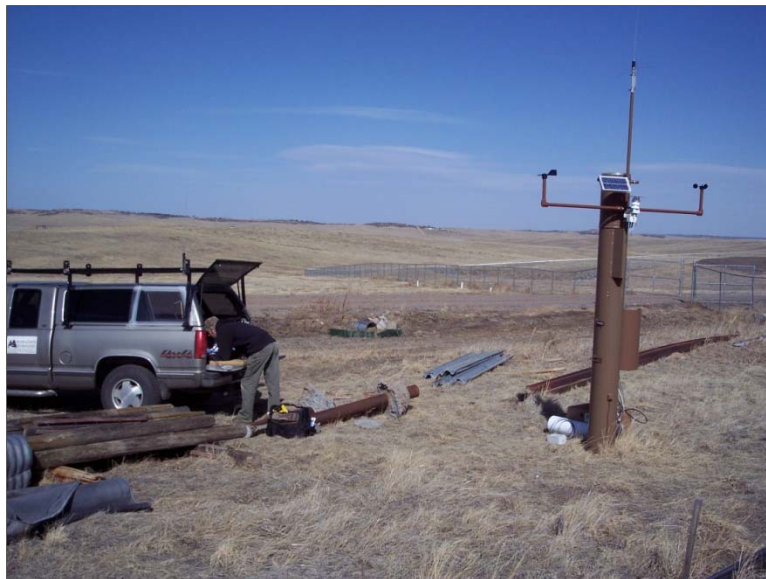
Photo 3-13. Spring Valley Road Wx

A second mid-season inspection was conducted on August 12, 2010. All equipment was checked, cleaned and tested. All equipment was in working order.

On December 9, 2010 a final inspection was performed. Since this is a weather station, it is operational throughout the winter so the transmitter was not removed. All equipment was checked, cleaned and tested. All equipment was in working order.

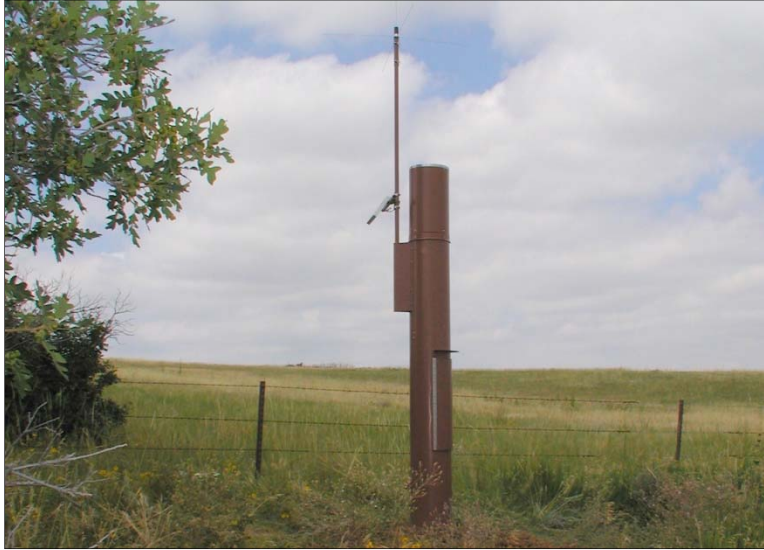
Photo 3-14. Willow Creek P

The mid-season low impact inspection was performed on June 30, 2010. All tested equipment was in working order.

On October 29, 2010 winter shut-down activities were performed by removing the transmitter.

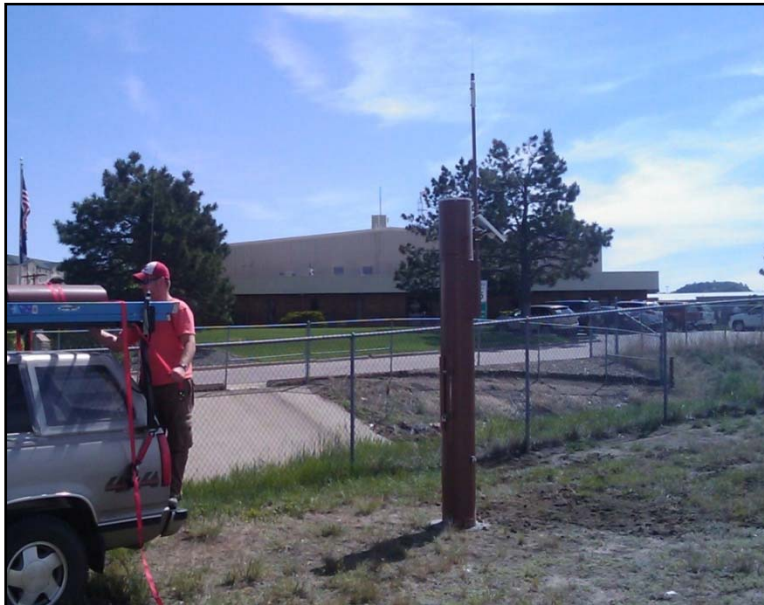
Photo 3-15. DC Public Works P

The station at the Douglas County Public Works was activated for the season on March 18, 2010. All equipment was checked, cleaned and tested. All equipment was in working order.

The mid-season low impact inspection was performed on June 30, 2010. All tested equipment was in working order.

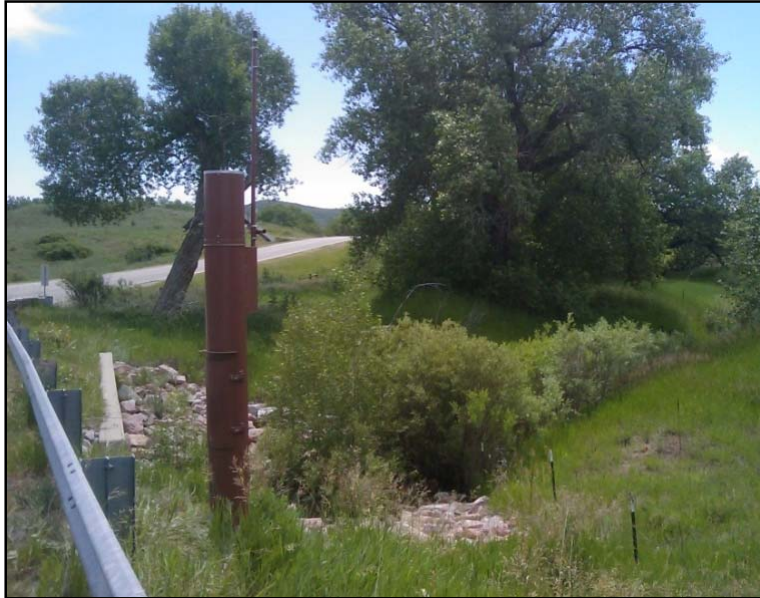
Photo 3-16. Indian Creek P

The station at Indian Creek was activated for the season on March 5, 2010. All equipment was checked, cleaned and tested. All equipment was in working order.

The mid-season low impact inspection was performed on June 30, 2010. All tested equipment was in working order.

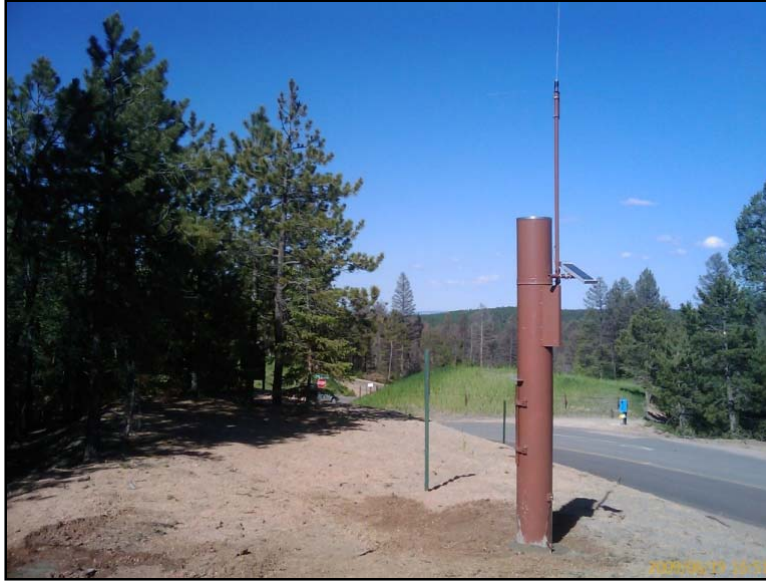
Photo 3-17. Rampart Range Road P

The station at Rampart Range Road was activated for the season on March 5, 2010. All equipment was checked, cleaned and tested. All equipment was in working order. Replaced the omni antenna with a Yagi directional antenna to improve reception at West Creek repeater.

The site was visited on April 28, 2010 to point the directional antenna direction. An amplifier was added on June 23, 2010.

On October 29, 2010 winter shut-down activities were performed by removing the transmitter

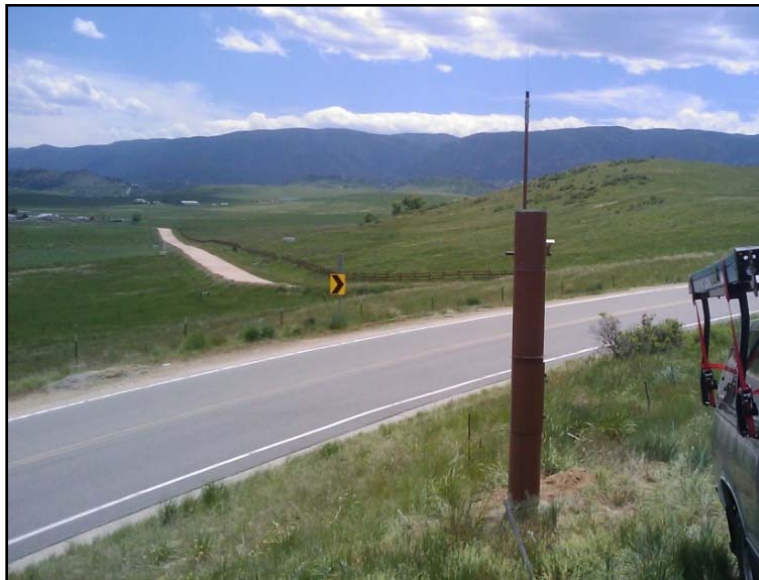
Photo 3-18. Dakan Road P

The station at Indian Creek was activated for the season on April 28, 2010. All equipment was checked, cleaned and tested. All equipment was in working order. This site was converted to a Campbell Scientific ALERT gage/repeater site to repeat transmissions from the gage at Highway 105 (3010).

The mid-season low impact inspection was performed on June 30, 2010. All tested equipment was in working order.

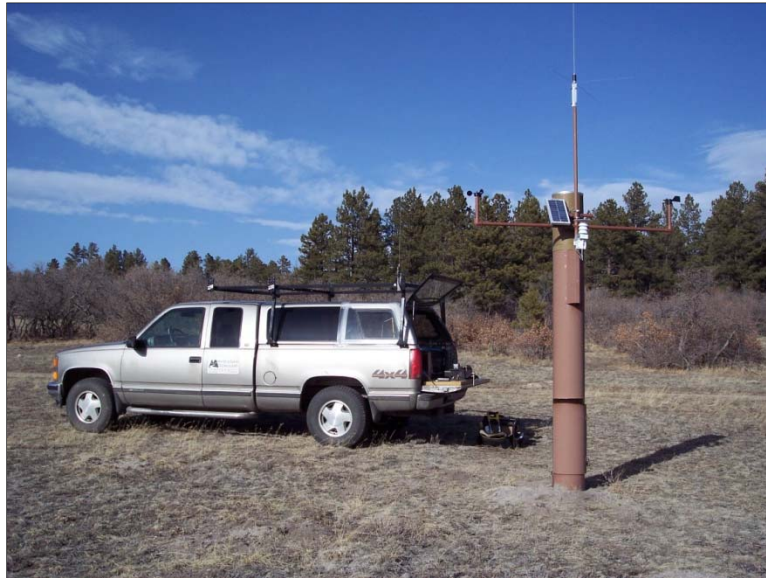
Photo 3-19. Tomah Road Wx

The pre-season inspection was conducted on March 18, 2010. All equipment was checked, cleaned and tested. All equipment was in working order.

The mid-season inspection was performed on June 23, 2010. All tested equipment was in working order. The funnel at this site always requires extensive cleaning. A bird of prey likes to dismantle its freshly caught prey while sitting on the rain bucket funnel.

On June 30, 2010 a service call was made to replace the transmitter because it was not processing the analog response from the RH sensor correctly. The faulty transmitter was shipped to Hydrolynx for repair.

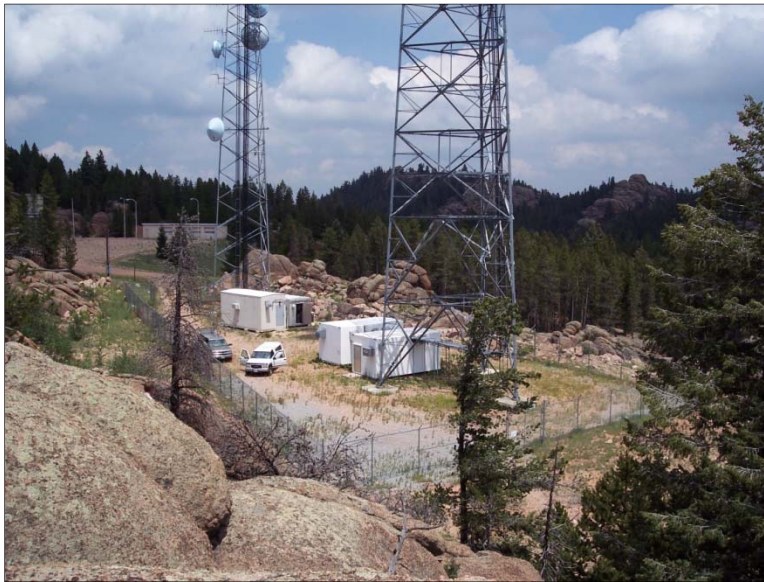
Photo 3-20. West Creek Repeater

A mid-season inspection was conducted on August 24, 2010. The battery charger was replaced to provide a higher voltage charge to the battery.

The end-season inspection was conducted on November 3, 2010. All equipment was checked, cleaned and tested. All equipment was in working order. Don van Wie installed a newer version of the ALERT2 Firmware.

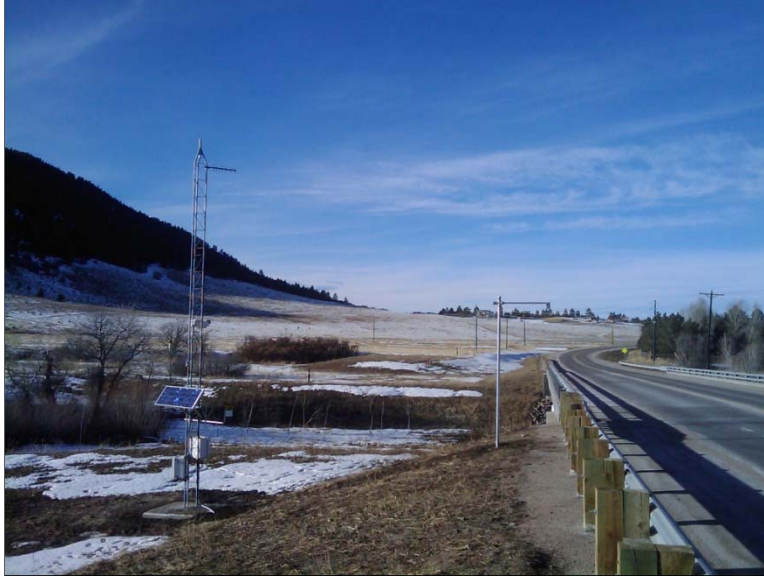
Photo 3-21. Highway 105 at Plum Creek

On June 23, 2010 the site was visited to replace the 12V sealed battery.

On August 24, 2010, the site was visited to remove a spider web from the pavement IR sensor.

On October 29, 2010 winter shut-down activities were performed. The transmitter was removed and the PT was pulled up into its winter location. All equipment was in working order. During the winter months, the site will continue to provide webcam images and temperature data to <http://www.wunderground.com/weatherstation/WXDailyHistory.asp?ID=KCOLARKS11>.

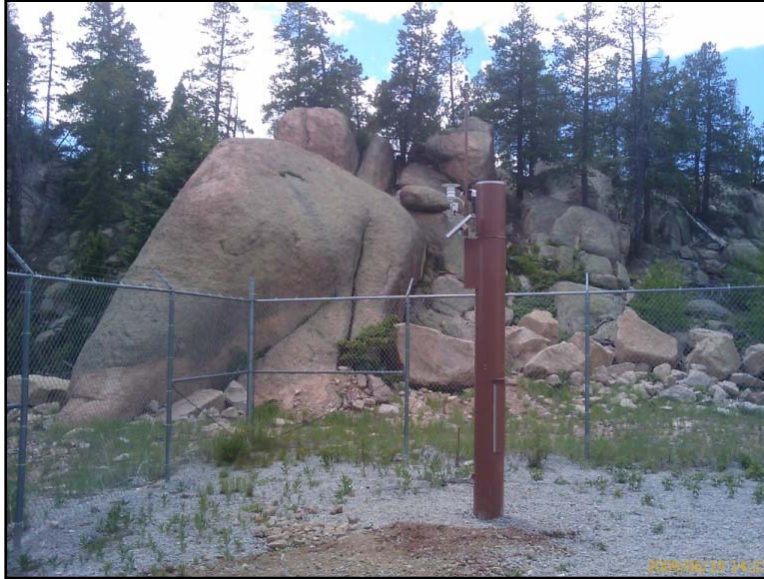
Photo 3-22. West Creek Wx

The mid-season inspection was performed on August 24, 2010. All tested equipment was in working order.

On November 2, 2010 a final inspection was performed. Since this is a weather station, it is operational throughout the winter so the transmitter was not removed. All equipment was checked, cleaned and tested. All equipment was in working order.
